**DUS News Digest**  
June 17, 2011 to June 24, 2011

Union Station Update #70.....Page 2  
June 24, 2011      *Denver Infill Blog*

By Rick Anstey, Denver Infill Blog

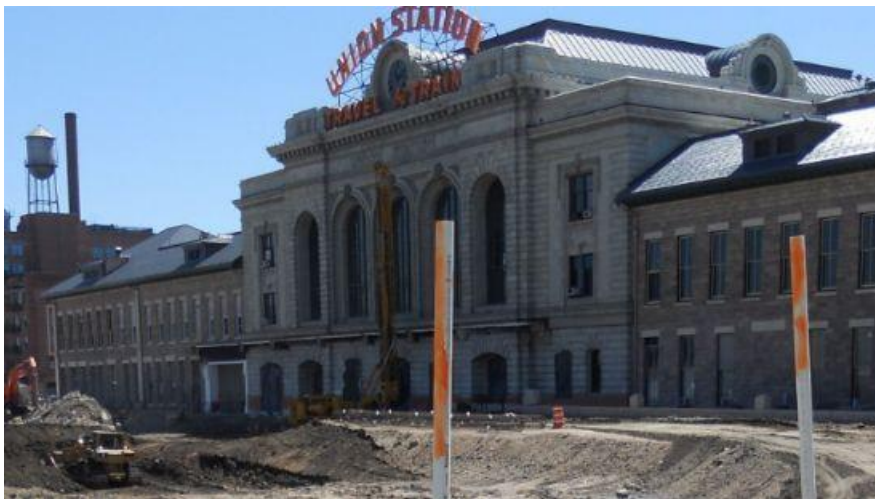
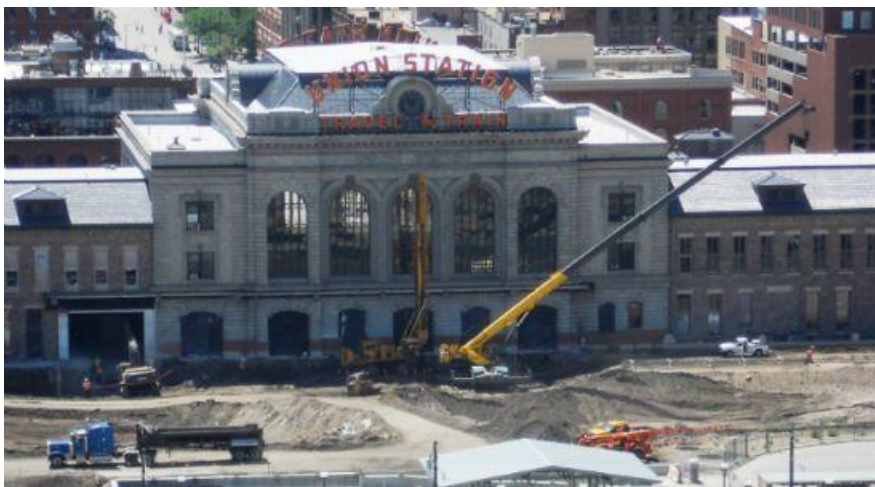
Here are two photos of the drilling process. I took the first one on Wednesday, and the second one this morning. The drill rig (you can see its vertical boom against the center of the station) drills the holes, and the crane in the second photo drops I-beams into the holes. The shoring wall will protect the station's foundation and prevent dirt from falling into the hole.

Remember shoring walls? The third photo in Update #30 is a good shot of one during the first phase of constructing the bus terminal. A new wall is now being built immediately behind the historic station in preparation for excavating the second half of the bus terminal hole. The process of building a shoring wall has several steps: (1) drill holes approximately 30 feet deep and about 20 feet apart; (2) drop an I-beam vertically into the hole; (3) back-fill the hole; (4) form the wall as dirt is being excavated by placing timbers into the slots created by the I-beams.

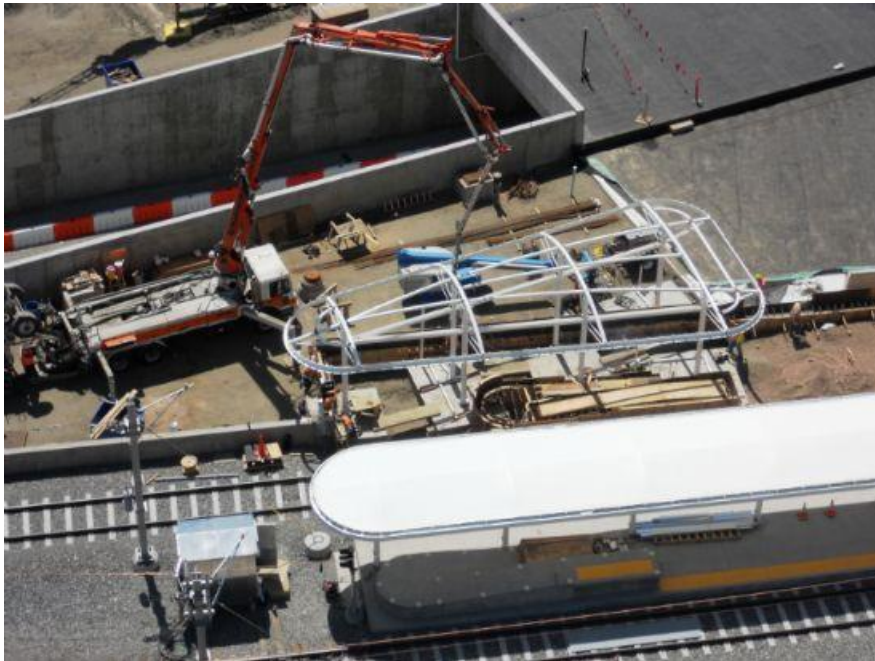
The overhead photo below shows further progress on the new light rail station. Concrete is being poured for a handicapped passenger ramp and the framework for the canopy has been installed. Follow this [link](#) to get a broad perspective of this part of the project. It's a rendering from Denver Union Station Project Authority's website. The canopy is visible as a tiny, white triangle in the upper center of the rendering.
